Investigation of Degradation in 20-Year-Field-Exposed PV Modules From India by Cross-Characterization Using Electroluminescence Imaging and Thermography

In this paper, an investigation of FEPV modules has been performed on 20-year-old modules degraded under India's sub-tropical climate conditions. The investigation has been performed by cross-characterization using DLIT and EL imaging techniques.

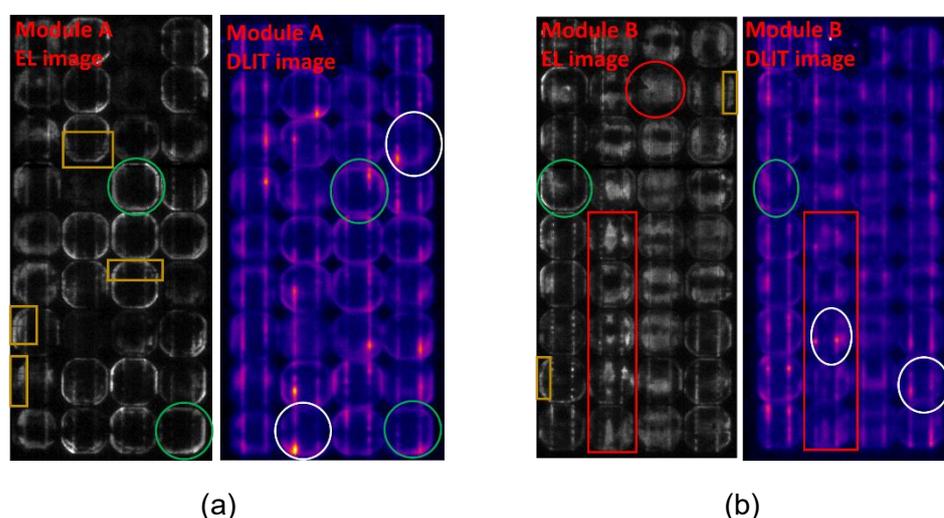
Discoloration is a widely reported degradation mode in PV module encapsulant caused by UV light and high temperature. Discoloration reduces the amount of radiation that reaches the solar cells through the encapsulant, which reduces I_{sc} of a PV module. Acetic acid and other gases produced as a co-product of the reaction for discoloration lead to corrosion and delamination in PV modules, which reduces the efficiency. The discoloration is typically non-uniform in the PV module, which causes mismatches within the cell and among the cells in a PV module which results in a drop in power [3]. Uneven encapsulant discoloration has been observed in EL images of FEPV modules as shown in Figure 2 (a), Figure 2 (b), and Figure 3 (a) (green encircled). Encapsulant discoloration has a dark appearance in EL images as it reduces the transmission of IR radiation. These dark patterns have also been visible in DLIT images as shown in Figure 2 (a), Figure 2 (b), and Figure 3 (a) (green encircled). It can be attributed to uneven heat absorption owing to uneven distribution of discoloration over the cells. Herein, the photobleached area has a bright appearance in DLIT images. Uneven discoloration observed in FEPV can be due to the photobleaching of encapsulant because of moisture ingress from the edge of solar cells and near the busbar. The presence of discoloration has also been confirmed by visual examination.

Figure 2. EL and DLIT images of (a) module A and (b) module B.

Degradation of solder bond between cell metallization (busbar) and copper ribbon interface due to thermomechanical fatigue or formation of intermetallic compound develops cracks in solder bonds. Also, moisture ingress in the PV module can cause corrosion by creeping into the joints at the solder bond which decreases the busbar contact with the copper ribbon. Solder bond degradation is one of the main reasons for increasing the series resistance (R_s) that can affect the reliability and performance of a PV module [5]. The busbar appears dark in EL images, making busbar-ribbon interface degradation difficult to identify. However, in DLIT bright spots on the busbar-ribbon interface can be seen as shown in Figure 2 (a), Figure 2 (b), and Figure 3 (a) (white encircled). It can be due to corrosion or solder bond failure or both. Corrosion and solder bond failure increases the heat dissipation due to joule heating at the degraded region and appears as bright spots in DLIT. In Figure 2 (b), it can be seen in red rectangular of the EL image as some bright regions in-between busbars and black regions near busbars. In the literature, it has been reported that these black spots in EL images were due to tin migration caused by solder material degradation [2]. These patterns have also been visible in the DLIT image of Figure 2 (b) (in red rectangular).

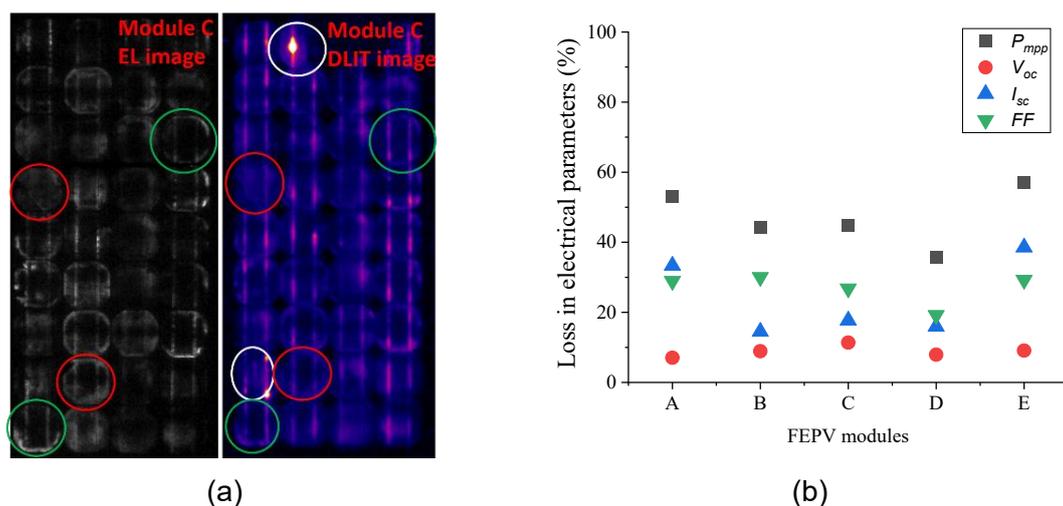
Cracks in the PV module are a significant issue that may introduce in the PV cells at the wafer phase, during cell/module manufacturing, and in handling during transportation and installation. In outdoor operating conditions, temperature cycling and mechanical loading can also propagate existing cracks or introduce new cracks in solar cells. Cracks can reduce the power/performance of PV modules over time and can cause electrical disconnection in certain areas of the cells [7]. Cracks have been observed in EL images (encircled in red) of modules B and C as shown in Figure 2 (b), and Figure 3 (a), respectively. Severe cracks in module C have appeared as a dark region in the DLIT image as shown in Figure 3 (a) (encircled in red). These cracks had delamination along their length which has been observed by visual inspection. The presence of delamination can be attributed to the moisture ingress from the back-sheet side through the gap in the severely cracked region.

Finger interruptions, which can occur during cell metallization and module lamination, are a prevalent problem in the screen-printed Si solar cells industry [8]. In field operating conditions, large temperature variations cause thermo-mechanical fatigue that can also result in finger interruptions in solar cells [9]. It can result in reduced performance of the PV module due to an increase in effective R_s . Interruptions of fingers have been observed in the EL images (enclosed in brown) of modules A and B as rectangular dark regions (lines) as shown in Figure 2 (a) and Figure 2 (b). However, they are not visible in DLIT images, which can be due to negligible effect on temperature.

Figure 3. (a) EL and DLIT images of module C, (b) Degradation in power at maximum power point (P_{mpp}) I_{sc} , V_{oc} , and FF in 20-year-old FEPV modules.

The impact of degradations has also been analysed on the electrical parameters of FEPV modules as shown in Figure 3 (b). A major impact has been observed on I_{sc} and FF that has decreased up to 40% and 30%, respectively. Analysis of EL and DLIT images has shown encapsulant degradation as the primary mode of degradation impacting I_{sc} . Busbar-ribbon interface degradation has been observed as another major mode of degradation that increases the R_s of the module and mainly affects FF. This shows that encapsulant and busbar-ribbon interface degradations are the two major modes of degradation that affect module performance under deployed Indian climatic conditions.
