Well Intended Contact Failures on Interdigitated Back Contact Solar Cells

Keywords: IBC, Interconnection Failures, Electroluminescence

The aim of this work is to study different connection failures in a Sunpower Maxeon III IBC cell [9] by EL imaging, demonstrating the feasibility of the measurement for early detection of possible failures in PV IBC panels.

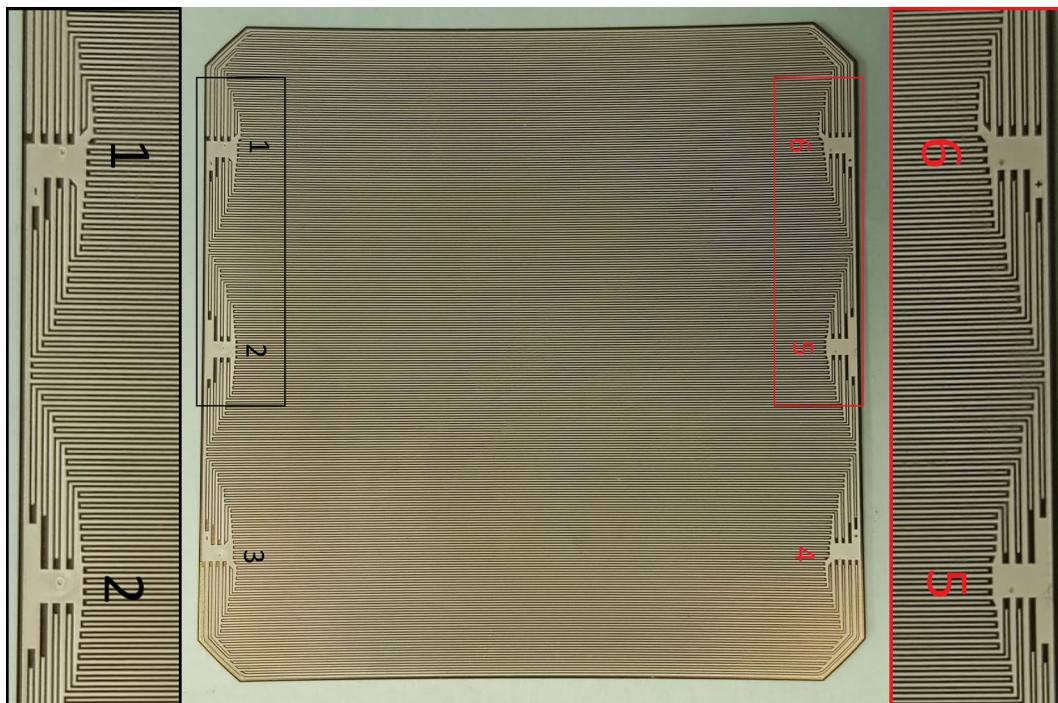
The cell under study is a Maxeon III IBC cell [10]. This cell has the connections of both polarities in the rear side, and presents three pads for the interconnection of the cells in the module. Figure 1 shows how each of the three pads has a tree-like structure, with the central trunk branching into several branches from which the metal fingers hang. These fingers run through the cell from one side to the other (horizontally in our image), with a single metal finger connecting the pads to each other, which makes the cell practically divided into three sub-cells. A mismatch in the connection between cells can cause a short-circuit between both polarities of the cell or can leave one third of the cell in open circuit. The latter scenario is analysed in this paper, being the short-circuit case outside the scope of this work.

Figure 1. Rear metallization and polarities in the Maxeon III IBC cell.

intentionally disconnected pads, simulating a soldering defect. The following table summarizes the different measurements performed. The nomenclature used is the following: **current_voltage_disconnected pad(s)**. The voltage refers to the value measured between pads 2 and 5 (see figure 1).

As discussed in a previous section, the cell under study is composed of three sub-cells connected by a single thin line (see figure 1). When all the pads are connected, the cell should radiate homogeneously. When one pad is disconnected, the corresponding cell third will be fed by the mentioned thin line, but this line will be able to handle only a low current.

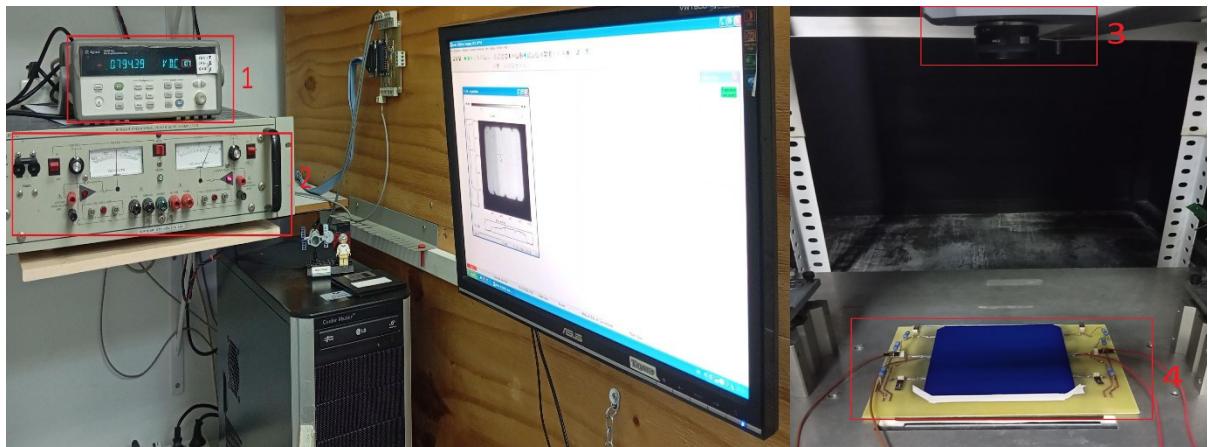
Figure 2. Equipment for the measurement. Multimeter, electronic load, and computer (LEFT) and CCD camera and homemade platform (RIGHT).

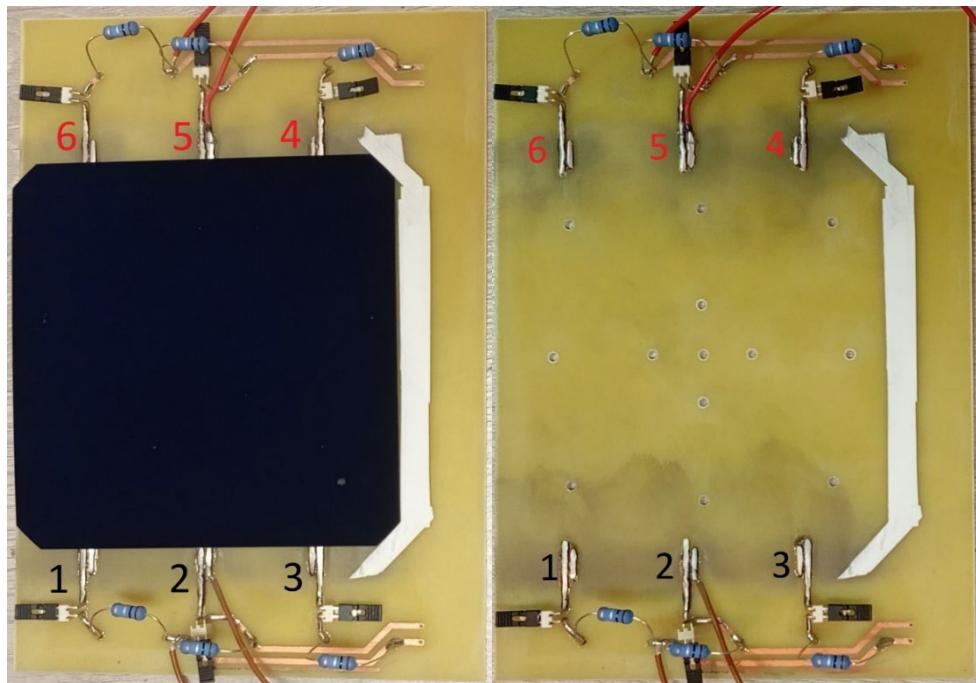
Figure 3 shows in detail the prototype specifically designed and manufactured to measure back-contact solar cells. This platform consists of 6 pads in accordance with the 6 pads of the solar cell shown in figure 1, 0.22 ohm resistors to equalize the current in the 3 sub-cells and jumpers that allow disconnecting the 6 pads at will. The IBC solar cell will be placed on the platform (LEFT) and the platform has also holes for the vacuum to hold the sample and make a good connection (RIGHT).

Figure 3. Connection prototype with a cell (LEFT) and showing the holes for the vacuum to hold the sample and make a good connection (RIGHT).

The following image shows an example of the acquired EL images. The position of the cell is the same as in the figure showing the prototype (figure 3). It can be seen that when all the pads are connected we can differentiate the three sub-cells, indicating there is still some resistance mismatch in the contacts of our prototype. The sub-cell on the left appears brighter when all the pads are connected, so we are going to show the results obtained when the pads of the right sub-cell are disconnected, as they seem to have a poorer connection already. These are pads 3 and 4. Although we only show these results, we remind you that all raw images are available for anyone who wants to consult them.

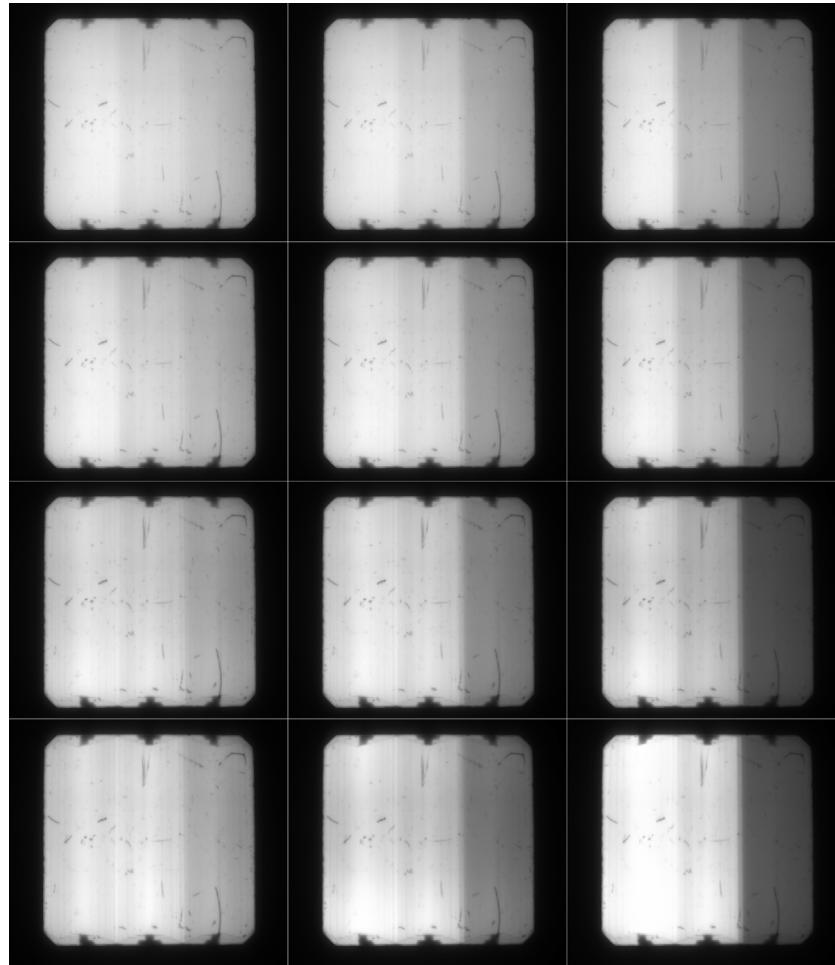
Figure 4. EL images from top to bottom: 1, 2, 4 and 6 amperes. Left images have all the pads connected, centre images have pad 3 disconnected and right images have pads 3 and 4 disconnected.

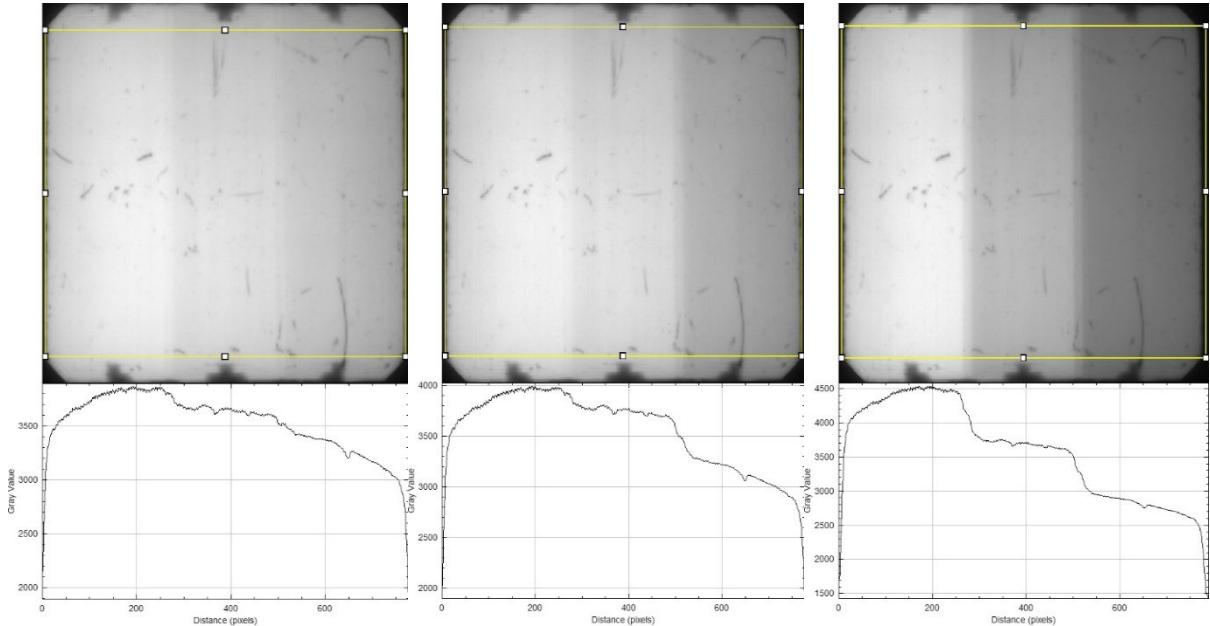
The raw EL images are sufficient to detect a connection failure at simple eye inspection. However, minimal image processing of these images can provide the input to an automated detection of this type of failure in a similar way to other proposals [11], [12]. Figure 5 shows some EL images and their corresponding horizontal profile. The step in the luminescent emission that indicates some failure in the connection of that part of the cell is detectable even at only 1 ampere. Images have been processed using ImageJ software [13].

Figure 5. EL images at 1ampere and their corresponding horizontal profile plots, with all the pads connected (LEFT), with pad 3 disconnected (CENTRE) and with pads 3 and 4 disconnected (RIGHT).

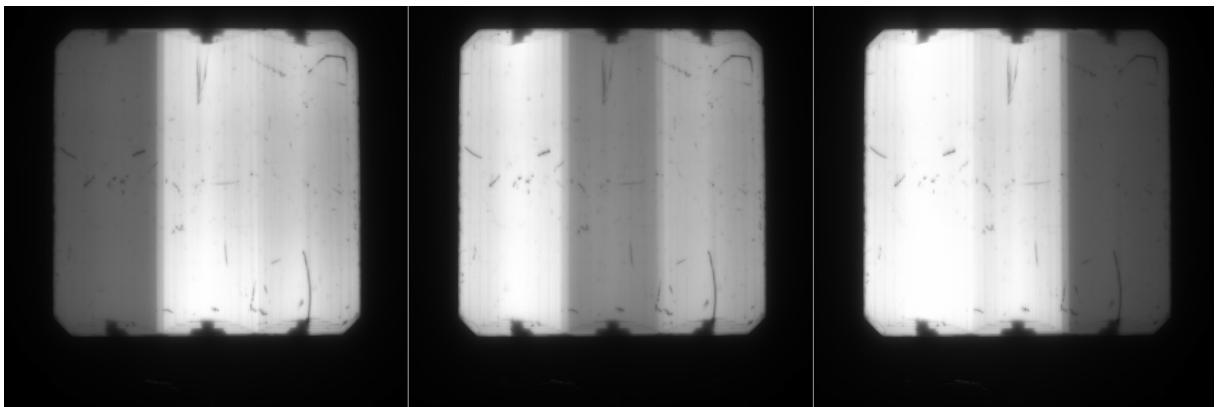
Although only 1 ampere and 0.5 seconds are enough to detect a connection failure in the cells, it must be taken into account that 1 ampere is a current value far from the normal working conditions of this type of cell. According to the manufacturer's data [14] these cells have an I_{MP} close to 6 amperes, exceeding this value at the short-circuit point. The following images show how in the event of a connection failure, current values close to 6 amperes will demand an overload of the adjacent sub-cells.

Figure 6. EL images at 6 amperes with a couple of pads disconnected: pads 1 & 6 (LEFT), pads 2 & 5 (CENTRE) and pads 3 & 4 (RIGHT).

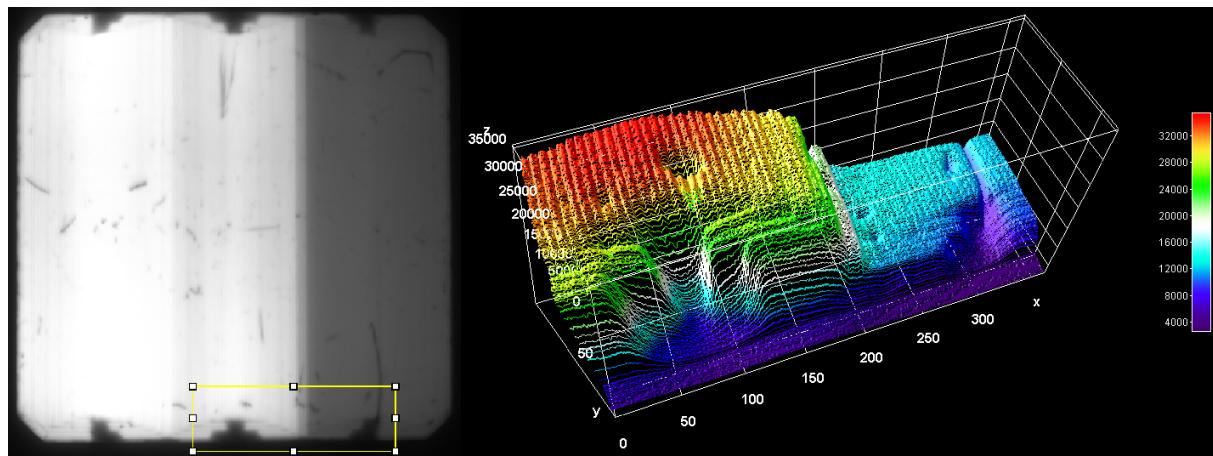
The analysis performed were meant to show how a fast EL acquisition and a simple image processing can be used to an automated detection of connection failures. However, further information can be extracted from more detailed inspection. Figure 7 shows how precise information of the emitted luminescence and its horizontal variation (meaning variation in the surface of the cell) can be obtained. Localized cell parameters can be extracted from the processing of this information like in previous works [15].

Figure 7. EL image at 6 amperes with pads 3 & 4 disconnected and the 3D surface plot of the area between the contacts (yellow box).
